## **Limited Visual Dam Safety Inspection Summary Report**

**MA-094**

**Kapalaalaea Reservoir**

**May 2006**

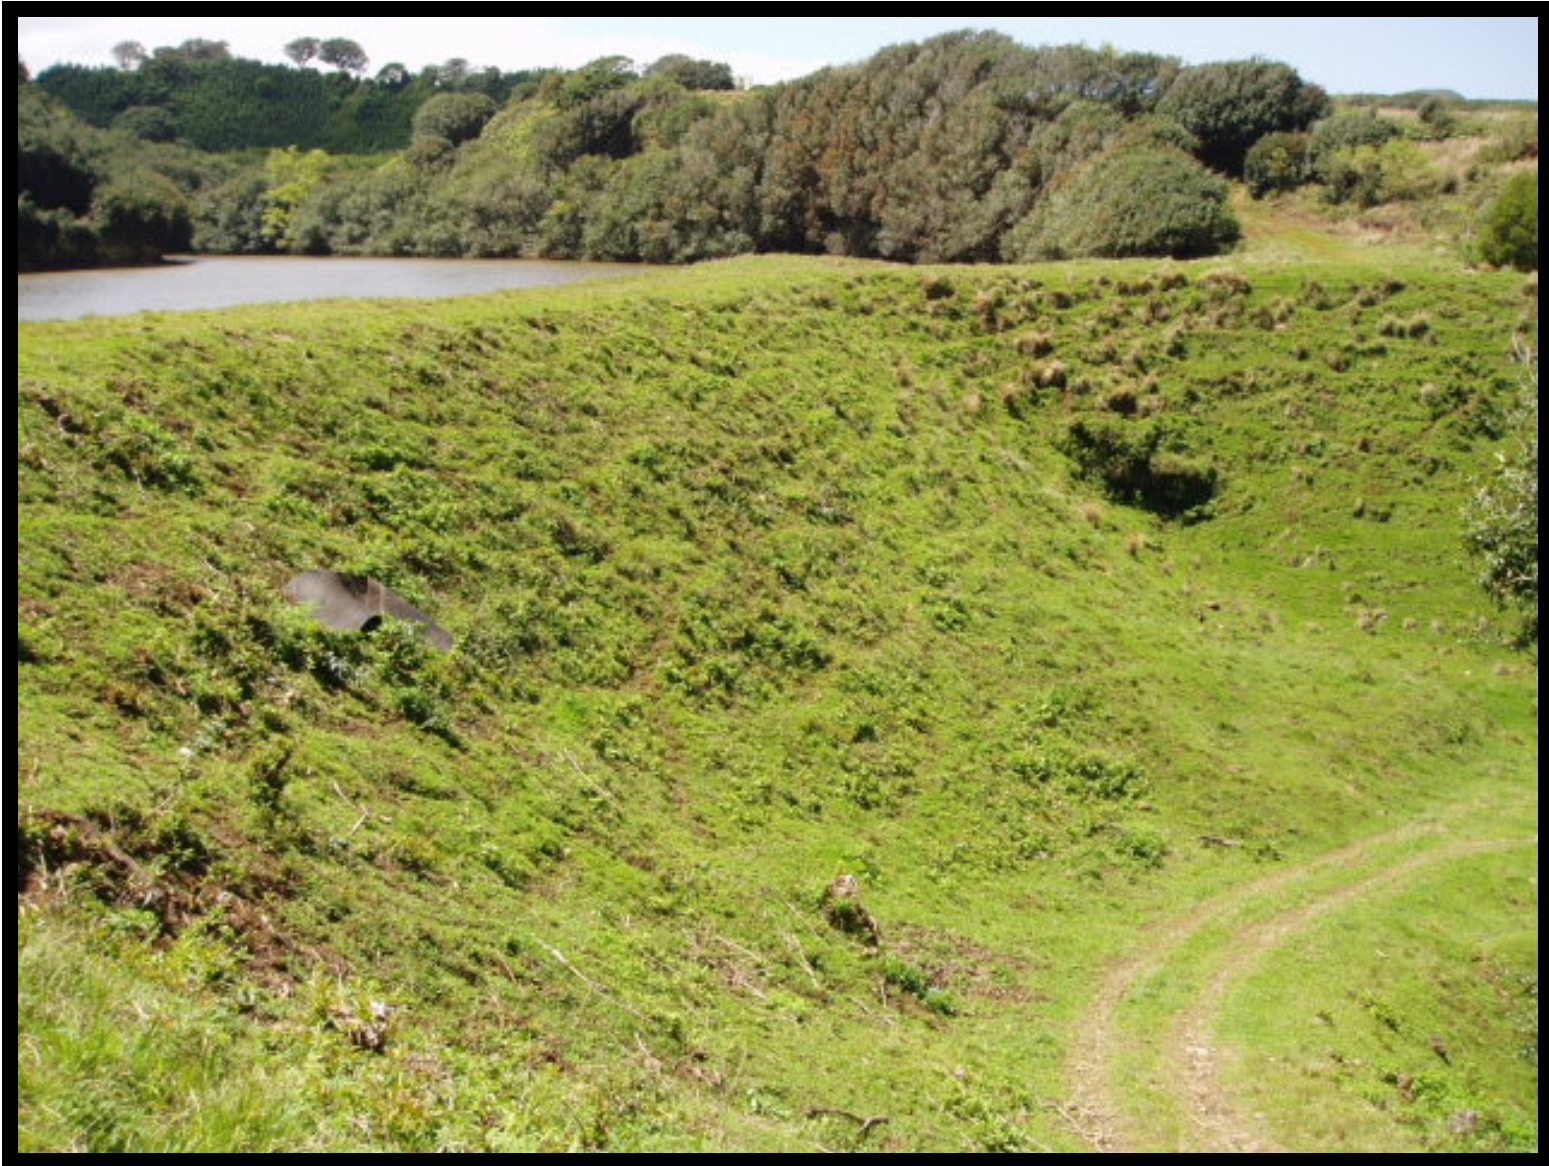
The downstream slope was approximately 1 on 1.5.

No erosion was observed on the downstream slope.

Sinkholes were not observed on the downstream slope.

There was low ground cover with short grass on the slope.

Seepage was not observed on the downstream.

- a. The downstream slope appeared to be in satisfactory condition, no corrective actions are required at this time.

094 downstream slope of dam

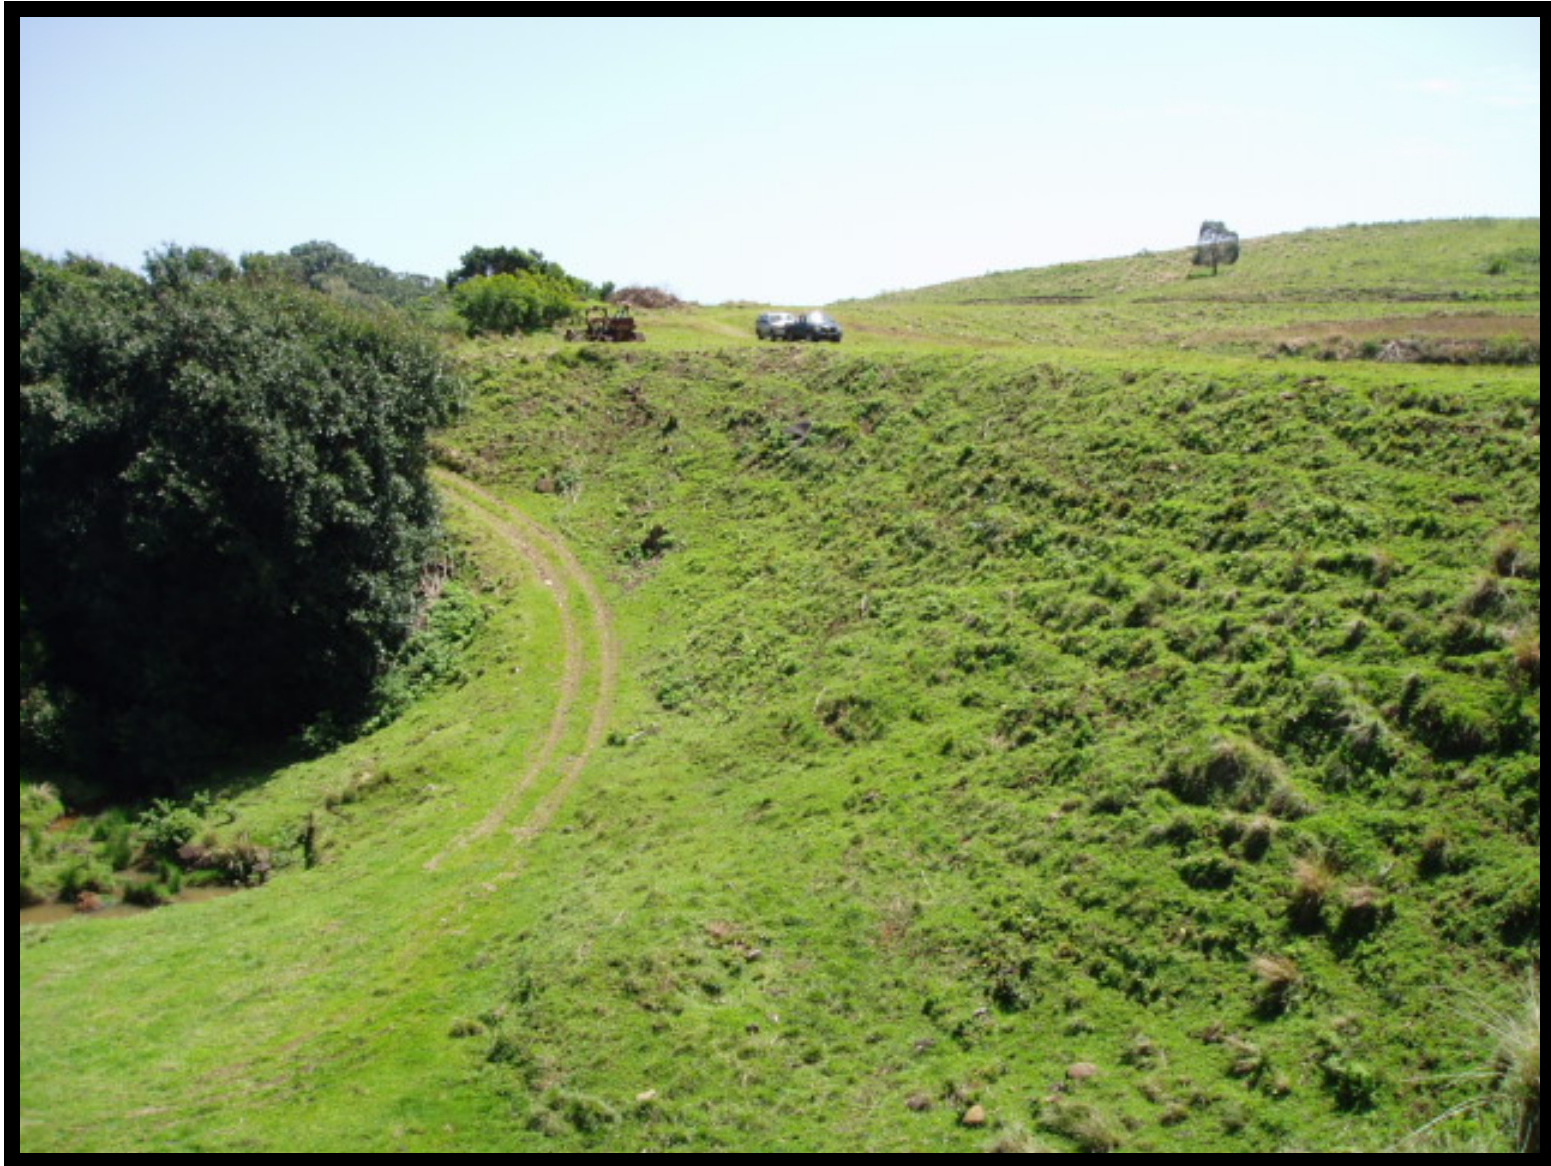
094 downstream slope of dam (panorama) 1

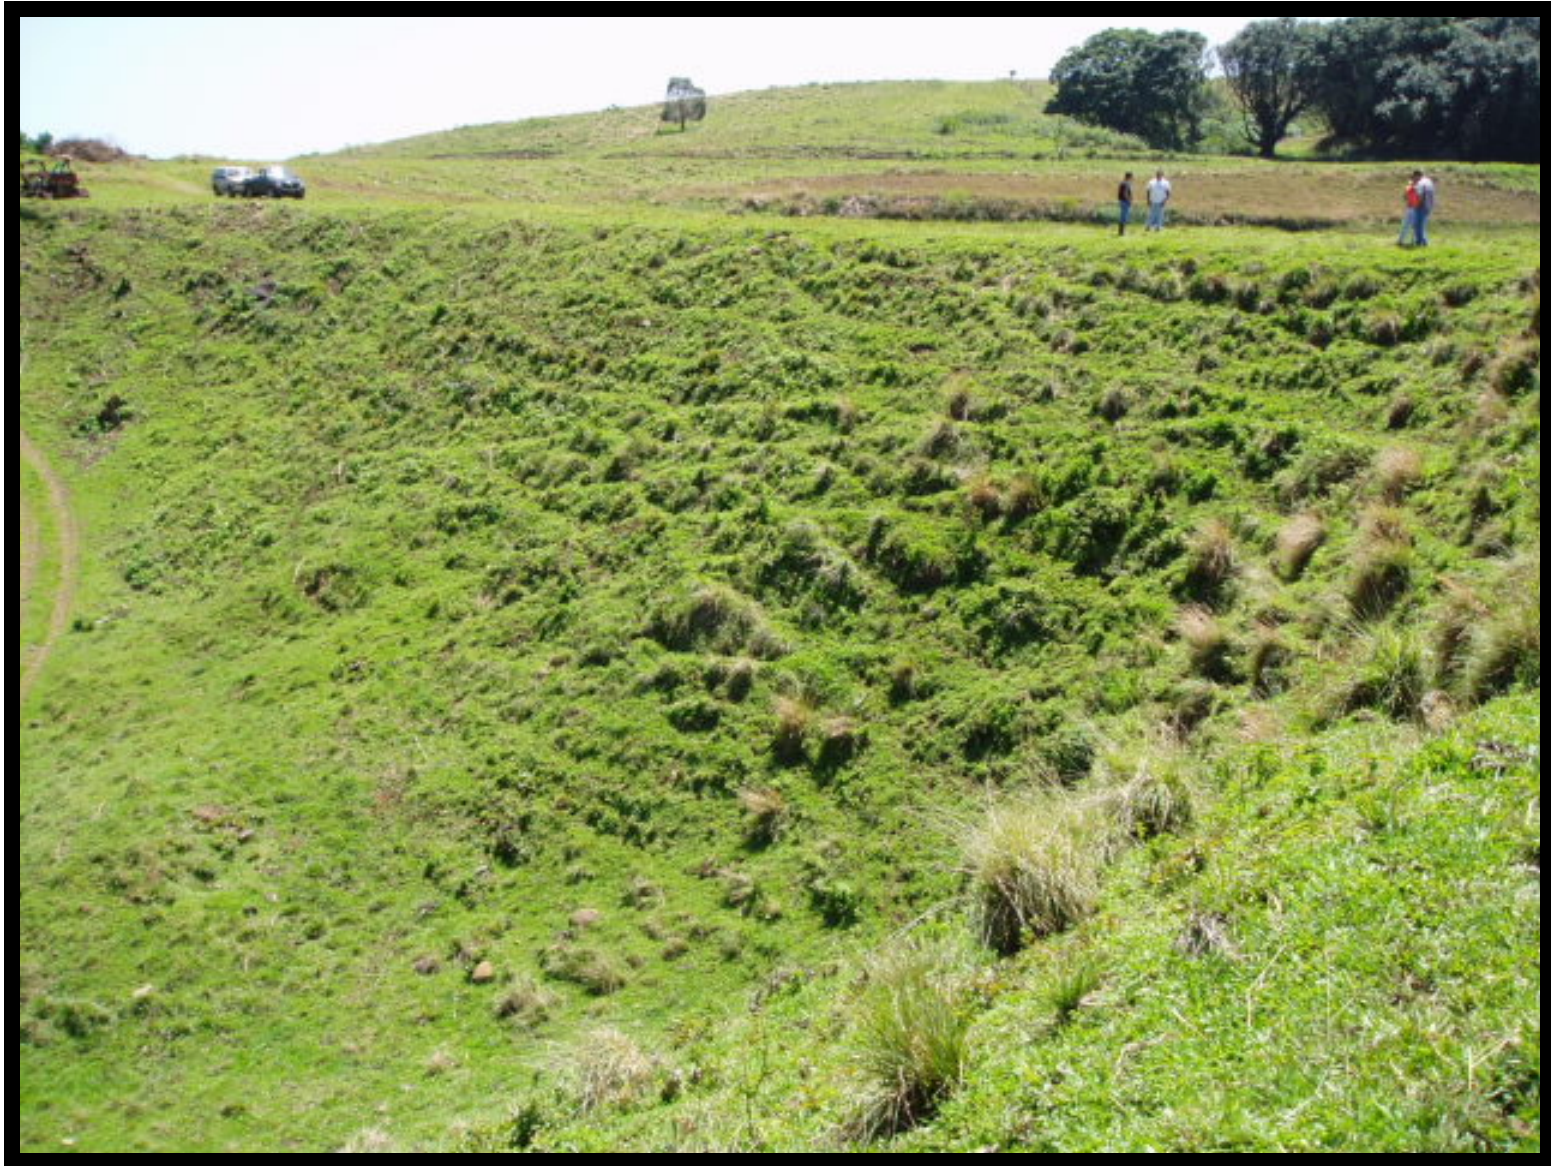
094 downstream slope of dam (panorama) 2

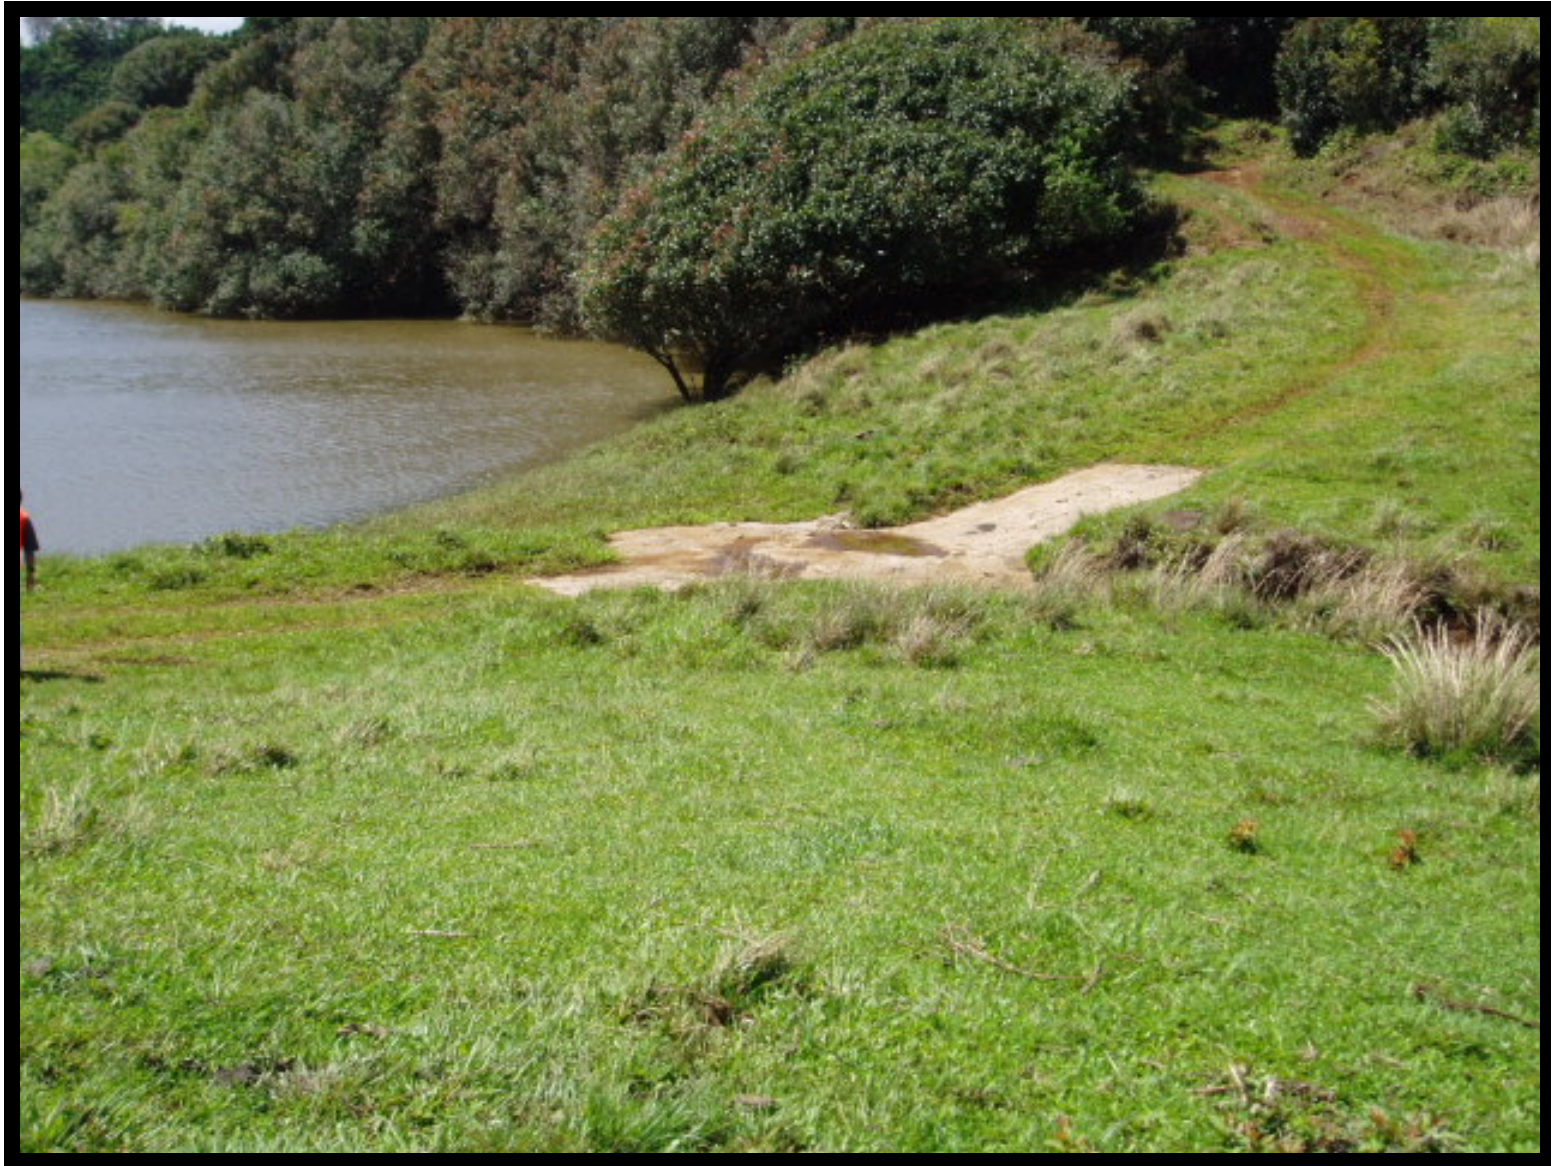
This spillway is consisted of a concrete apron that is located on the left abutment.

The dimension is 20 feet.

The spillway approach was clear.

There was no erosion observed near the spillway.

- a. The Spillway appeared to be in satisfactory condition, no corrective actions are required at this time.

094 spillway
